Passaic Valley Sewerage Commissioners Response to Request for Information USEPA, Region 2

Service Area Drainage and
Land Use Report
for the Towns of
Harrison and Kearny,
The Borough of East Newark, and the
Cities of Newark and Paterson

Appendix C

City of Newark

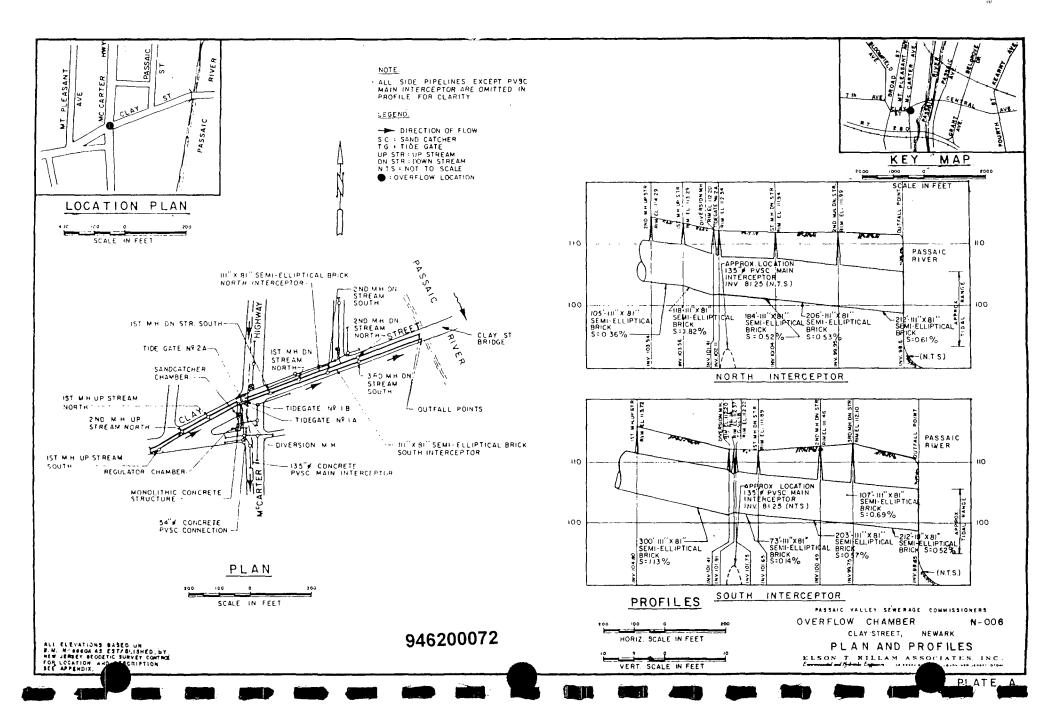
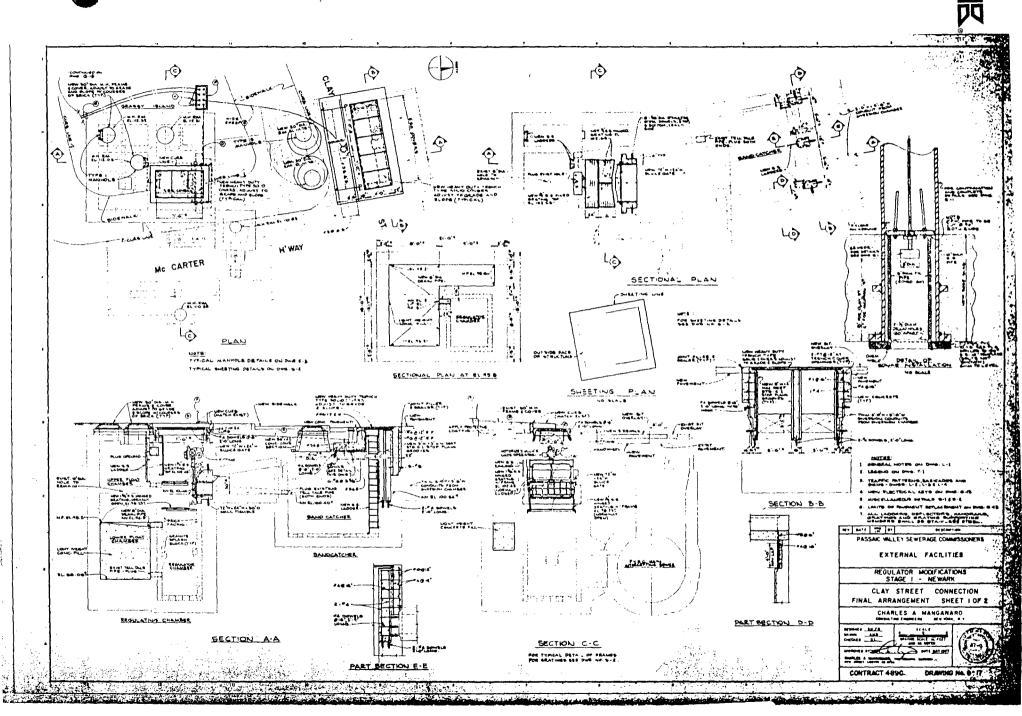
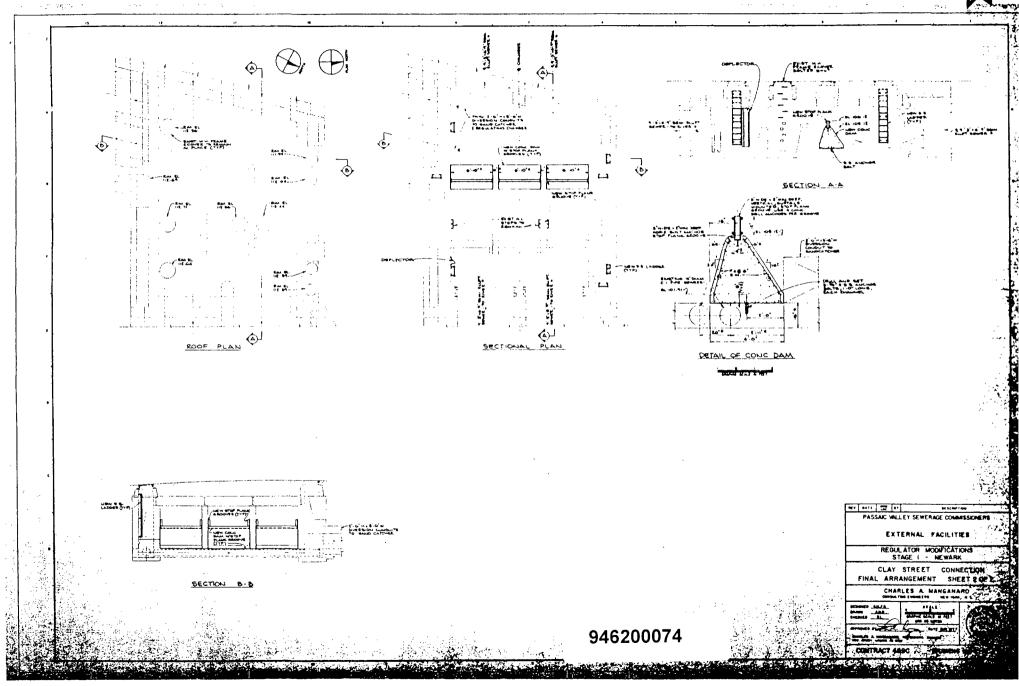
2nd tide gate on southernmost opening jammed open, as well as 1st tide gate on center opening. All other gates appear to be leaking (See Plate B).

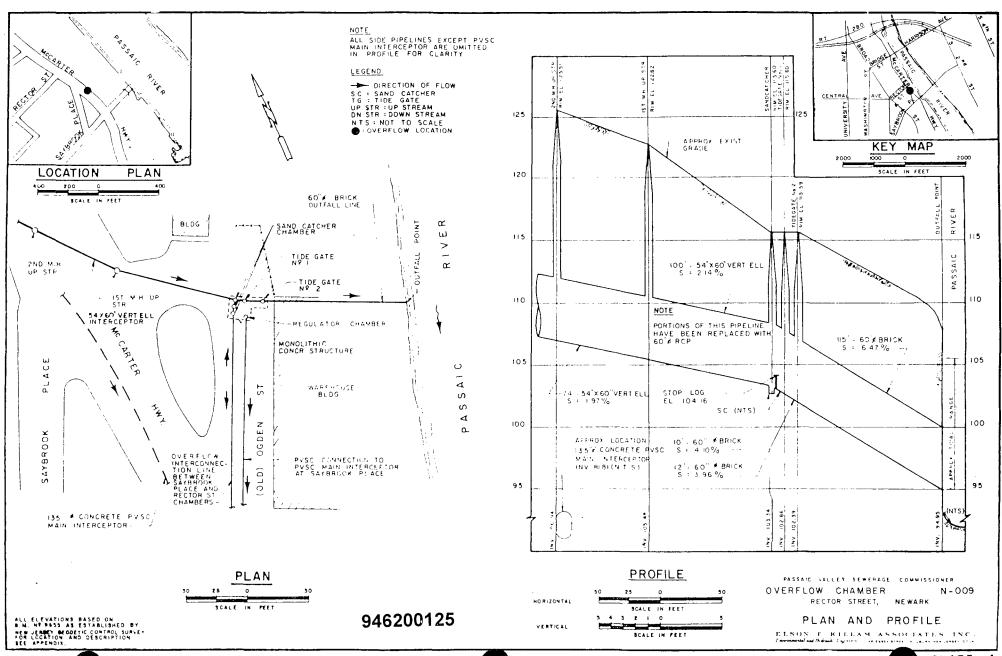
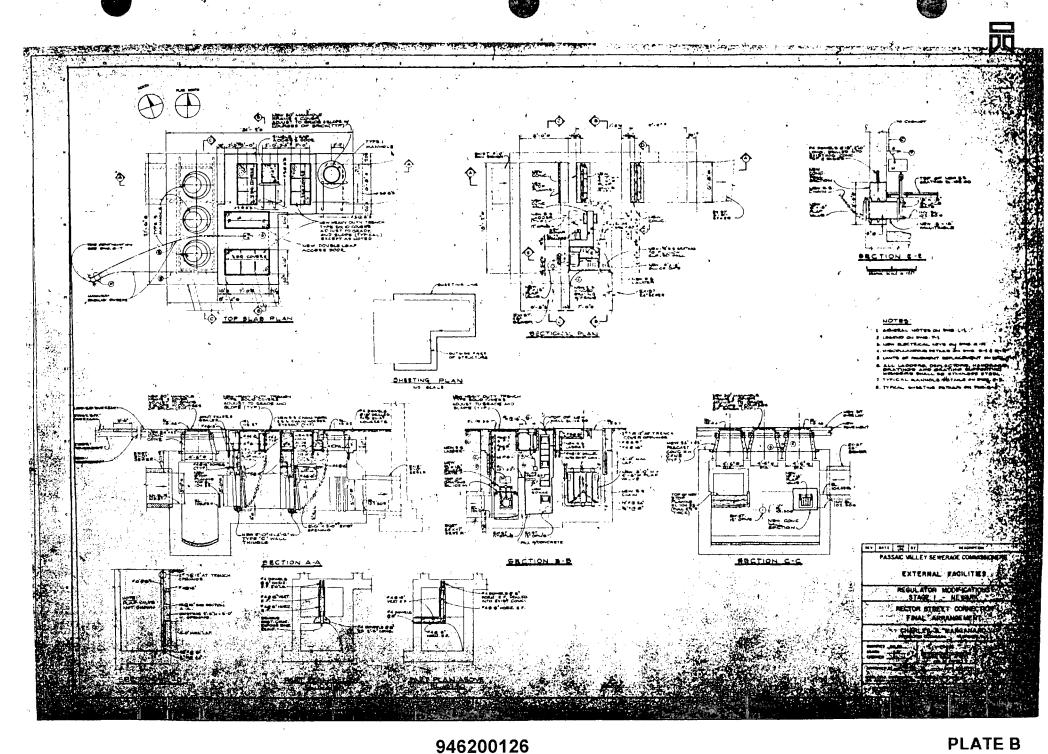
PLATE B

both gates leaking
